How to make Stone Masonry Buildings Earthquake Resistant?

Behaviour during Past India Earthquakes

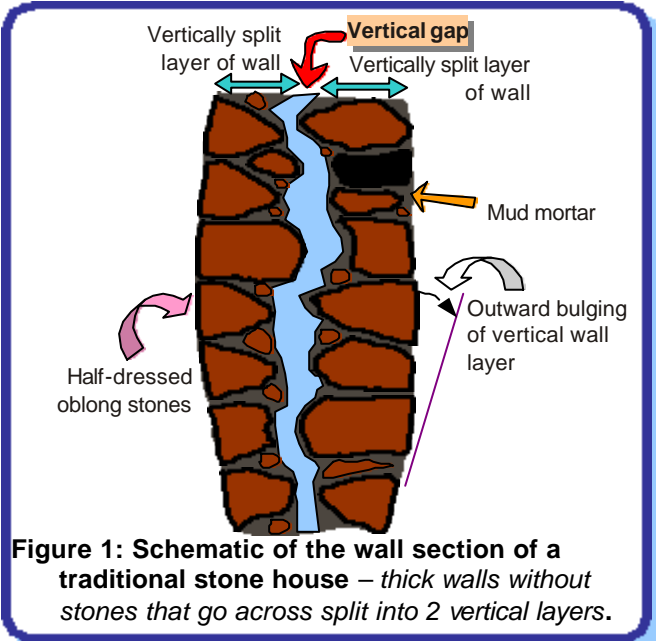
Stone has been used in building construction in India since ancient times since it is durable and locally available. There are huge numbers of stone buildings in the country, ranging from rural houses to royal palaces and temples. In a typical rural stone house, there are thick stone masonry walls (thickness ranges from 600 to 1200 mm) built using rounded stones from riverbeds bound with mud mortar. These walls are constructed with stones placed in a random manner, and hence do not have the usual layers (or *courses*) seen in brick walls. These uncoursed walls have two exterior vertical layers (called *wythes*) of large stones, filled in between with loose stone rubble and mud mortar. A typical *uncoursed random (UCR)* stone masonry wall is illustrated in Figure 1. In many cases, these walls support heavy roofs (for example, timber roof with thick mud overlay).

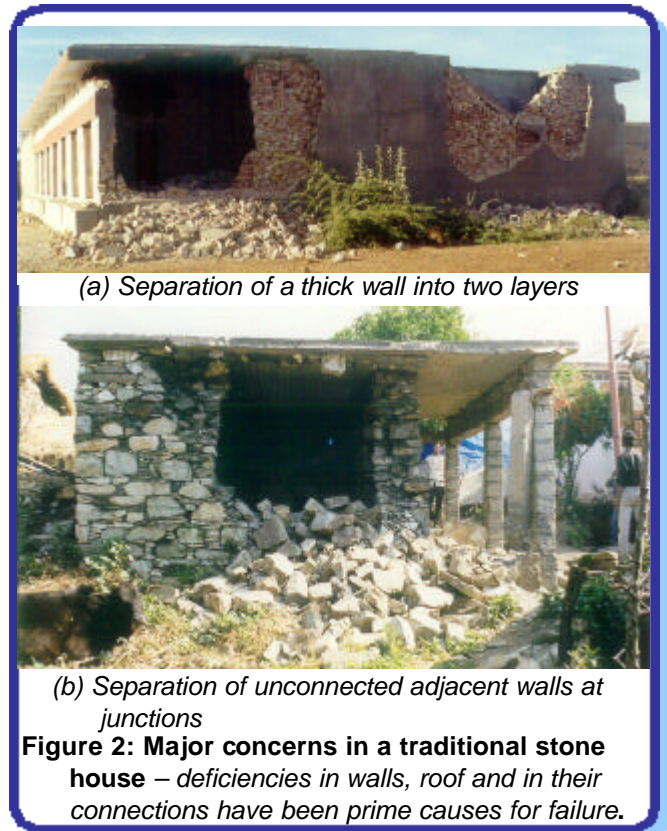
The main patterns of earthquake damage include: (a) bulging/separation of walls in the horizontal direction into two distinct *wythes* (Figure 2a), (b) separation of walls at corners and T-junctions (Figure 2b), (c) separation of poorly constructed roof from walls, and eventual collapse of roof, and (d) disintegration of walls and eventual collapse of the whole dwelling.

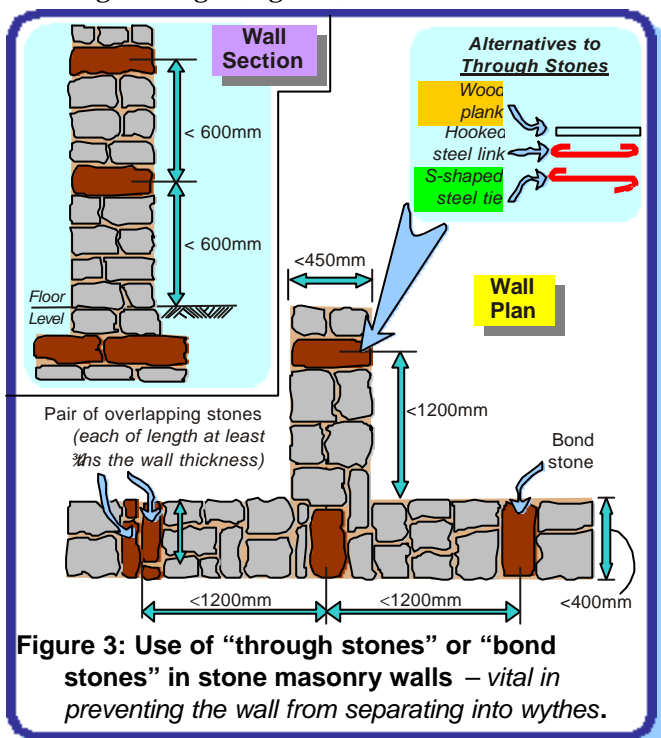
- (a) **Ensure proper wall construction** The wall thickness should not exceed 450mm. Round stone boulders should not be used in the construction! Instead, the stones should be shaped using chisels and hammers. Use of mud mortar should be avoided in higher seismic zones. Instead, cement-sand mortar should be 1:6 (or richer) and lime-sand mortar 1:3 (or richer) should be used.
- (b) **Ensure proper bond in masonry courses:** The masonry walls should be built in construction lifts not exceeding 600mm. *Through-stones* (each extending over full thickness of wall) or a pair of overlapping *bond-stones* (each extending over at least $\frac{3}{4}$ th thickness of wall) must be used at every 600mm along the height and at a maximum spacing of 1.2m along the length (Figure 3).

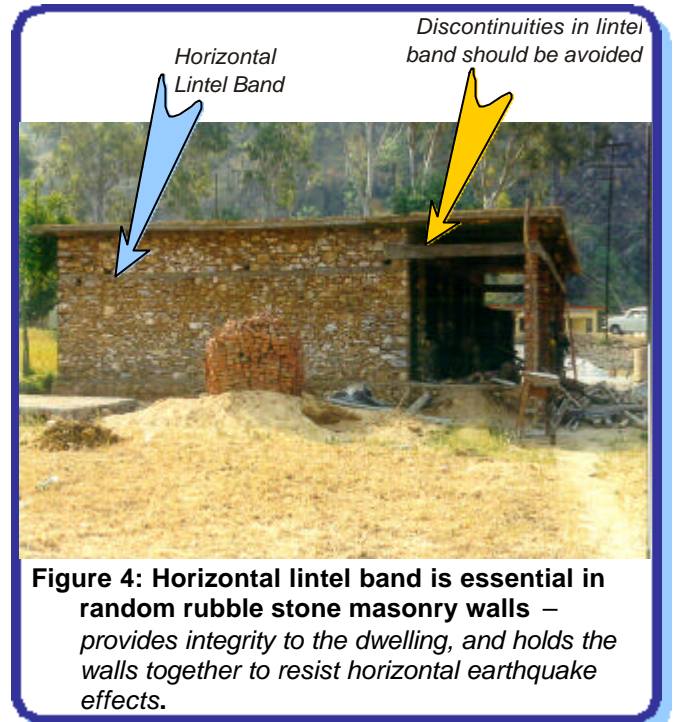
- (c) **Provide horizontal reinforcing elements:** The stone masonry dwellings must have horizontal bands (See IITK-BMTPC Earthquake Tip 14 for *plinth, lintel, roof* and *gable bands*). These bands can be constructed out of wood or reinforced concrete, and chosen based on economy. It is important to provide at least one band (either *lintel band* or *roof band*) in stone masonry construction (Figure 4).

resistance, its extensive use is likely to continue due to tradition and low cost. But, to protect human lives and property in future earthquakes, it is necessary to follow proper stone masonry construction as described above (especially features (a) and (b) in seismic zones III and higher). Also, the use of seismic bands is highly recommended (as described in feature (c) above and in IITK-BMTPC Earthquake Tip 14).
